**ACCIDENT FINAL REPORT
PROBABLE CAUSE REPORT**

FILE No. **ACCDTARA004/2018MMPB**

Aircraft: Agusta Brand, Model A1095, Serial Number 22174, Registration XA-BON.

Date and Time: 02:35:40 p.m. (20:35:40 UTC); December 24th, 2018.

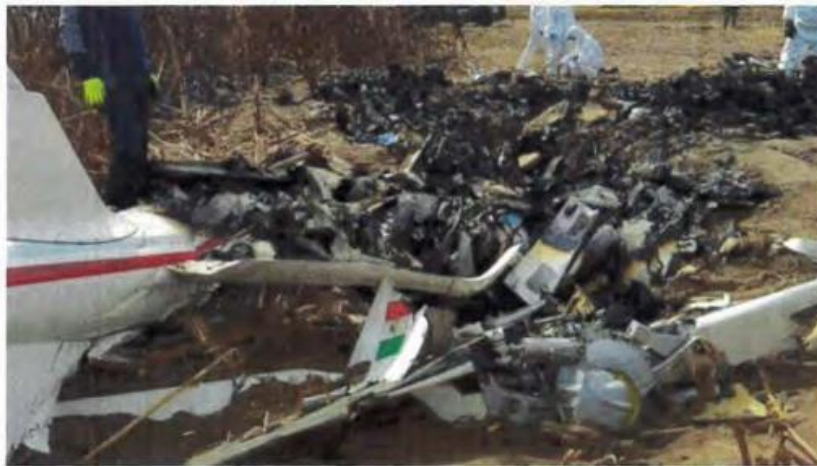
Fig. 1.11.1. XA-BON helicopter damage.

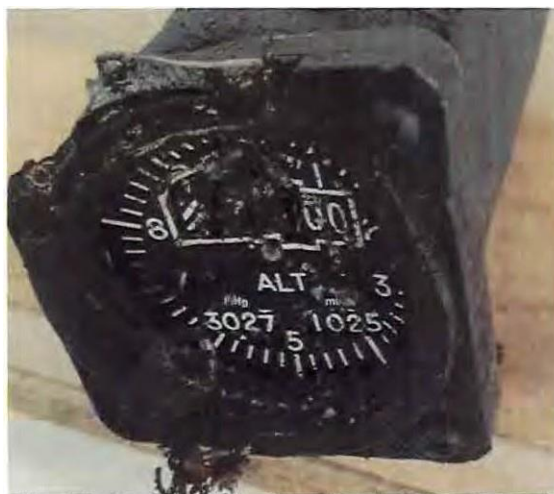
The flight control instruments and controls were also destroyed; only the right-side radio altimeter was rescued, which is shown in figure 1.15.2.2, showing a reading of 1,600 feet (1,025 hPa setting).

Fig. 1.15.2.2. Radio altimeter with the indication of 1,600 feet above ground.

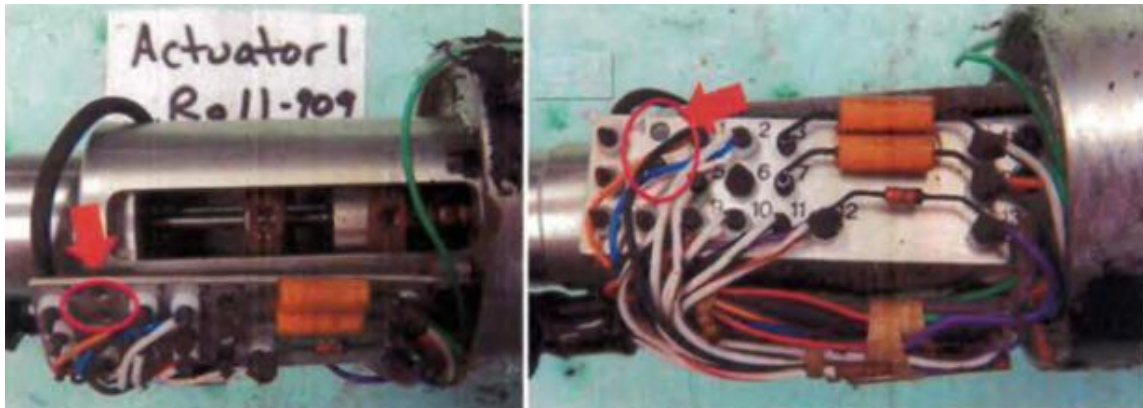
The SAS1 roll linear actuator (P/N 4012373-909, S/N see r 3-409) had 2 of the 4 retaining screws that hold the electronics board to the actuator body completely unscrewed and moved freely between the metal actuator body and the LVDT housing.

3.1 SAS1 roll linear actuator with missing screws and the ball screw showing a roll to the left

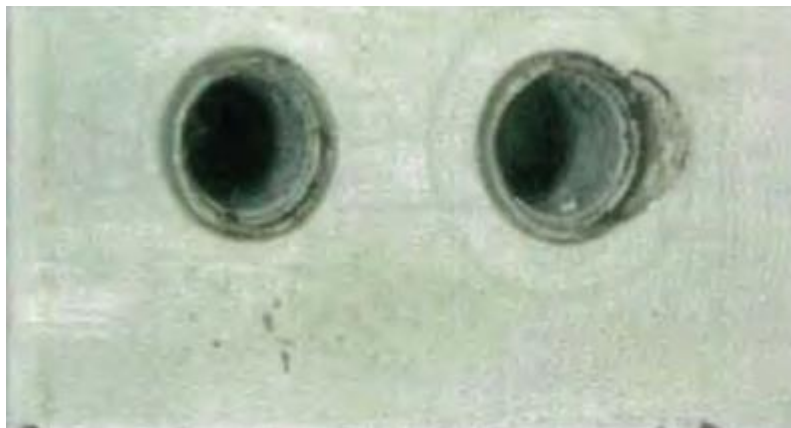
In one of the holes in the casing it was detected that the threading showed damage near the outer edge of the hole with a thread impression.

2.2.2.2.b Close-up of damage to a near-thread impression

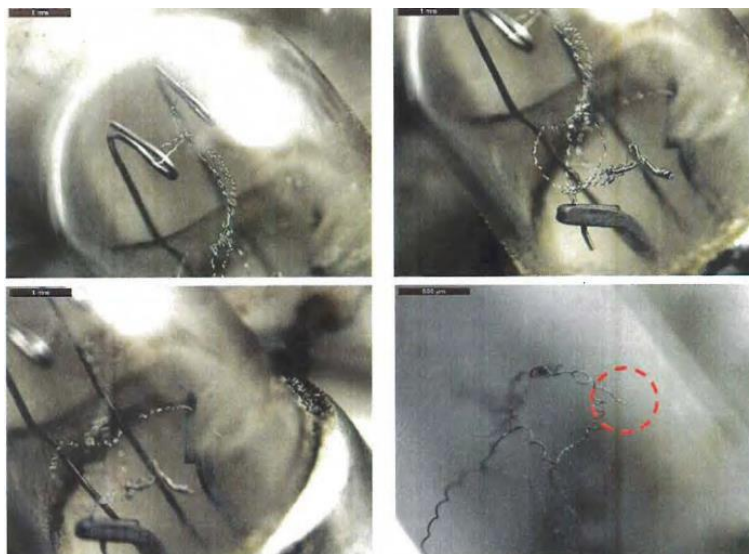
3.1. MC bulb B, glass cover intact, fractured filament (red circle) with high deformation.

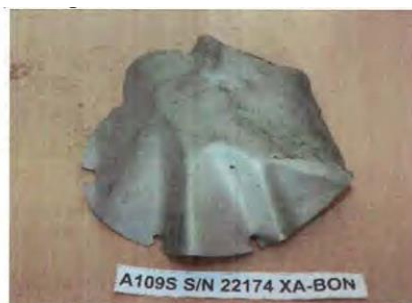
1.3.b. The cover is deformed upwards

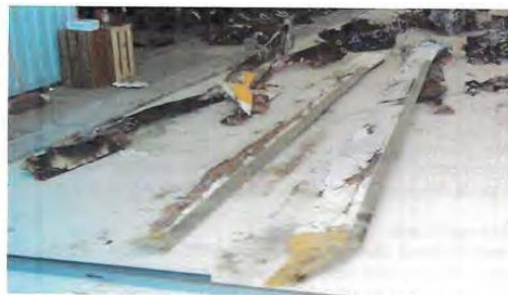
1.7.4.a. Damage to all four main rotor blades

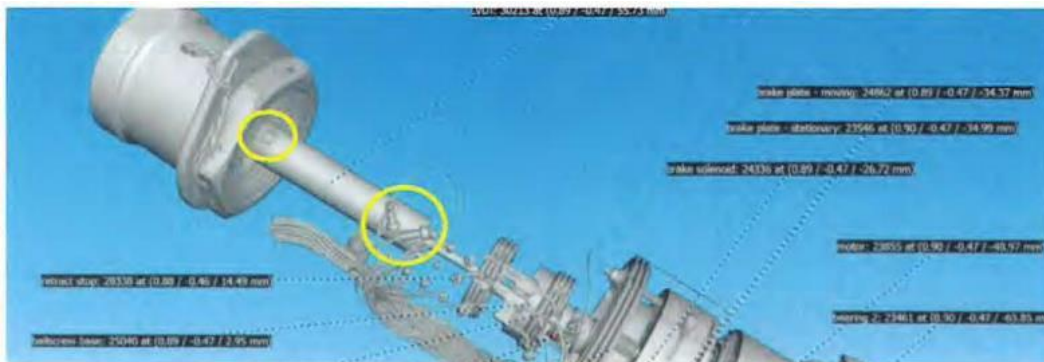
Fig. 1.a. Two loose screws and a washer are observed.

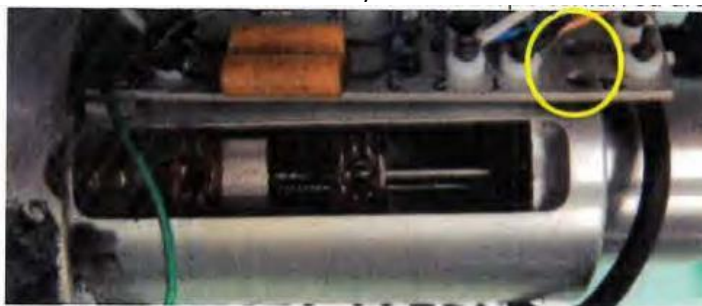
2.1.c. Two front screws holding the card to the actuator body were not found in their design position

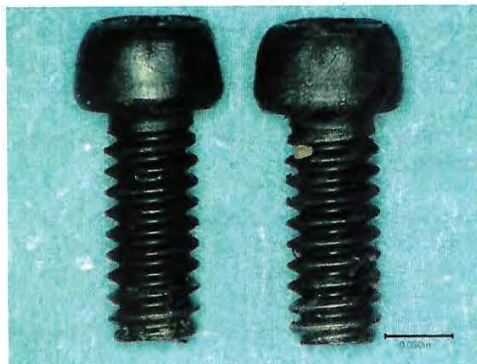
4.1.a Microscopic digital image of the screws removed from side 2.
